Investigation of a Highway Bridge

INVESTIGATION OF A HIGHWAY BRIDGE

WALTER WASHINGTON KERCH

The bridge in question is commonly known as the Woolen Mill Bridge, and spans the Vermillion River at Danville, Illinois. It was built by the Lafayette Engineering Company of Lafayette, Indiana, the metal all being from the Oliver works.

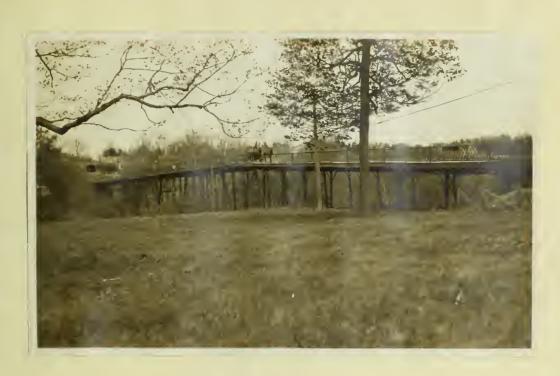
PLATE I

The structure is shown in Plates I and II. As seen in the outline diagram, the bridge consists of a river span and two viaduct approaches. The channel span is a Whipple or double Intersection deck truss bridge of ten panels, each panel being seventeen feet, three inches long. The west approach is built on a three per cent grade, and consists of nine trestle bents seventeen and a half feet apart, with built up metal sections for supports. The east approach consists of five deck Pratt trusses of four panels, each panel being seventeen feet, three inches long, together with four trestle bents the same as in the west approach. The roadway is seventeen feet wide, with two four-foot sidewalks, one on each side. The west abutment of the river span and the foundations of all the bents are of sandstone. The east abutment of the river span consists of two iron tubes filled with concrete, these tubes being braced by lateral stays and struts. The bridge was built to con-
